BUILDING INSPECTION REPORT

In accordance with AS 4349.1

BOO-27468-Z0F6B9
Report Number

45 Bellevue Drive, Little Mountain, QLD 4551
Inspection Address

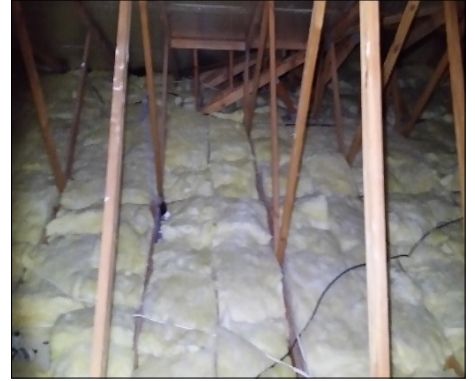
Roof Void because:

Visual inspection to some timbers in the roof void were obstructed due to the design of the roof which restricted bodily access.

Restricted visibility to soffits/eaves.

Insulation batts obstruct visual inspection.

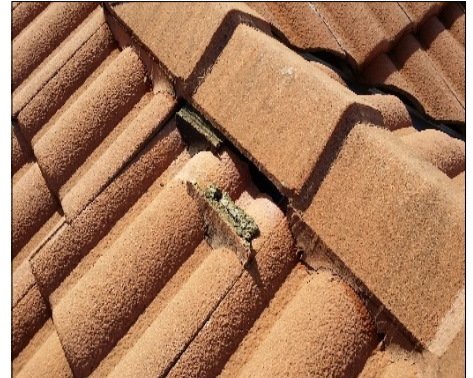
Yes Roof Plumbing and Flashings

Cracking was detected to mortar in parts of capping tiles and hips/ridges, re-pointing is recommended. Recommend seeking further advice from a licensed and practicing roof tiler.

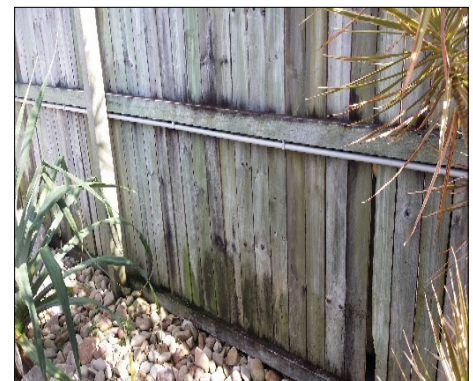
Yes Decay / Corrosion

Timber fences have signs of decay and weathering, repair or replace where required. Recommend seeking further advice from a licensed and practicing carpenter.

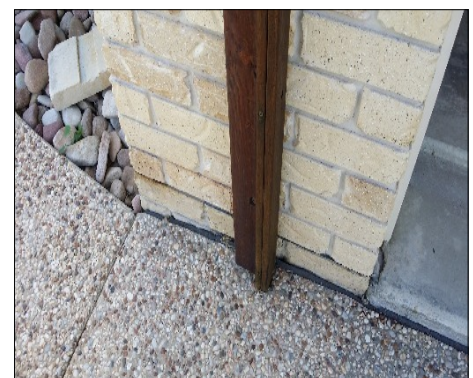
Yes Other Conditions Conducive

Any side connecting structures, gate/fence supports or any timbers which are attached to the dwelling and in contact with the ground may conceal termite entry points. A 75mm clearance from the ground or reconstruction is recommended.

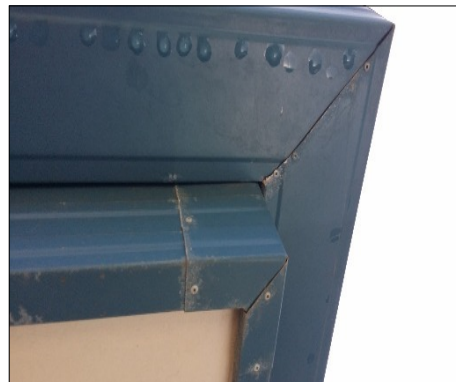
Minor paint defects to exterior gutters and metal fascias, paint touchups recommended.

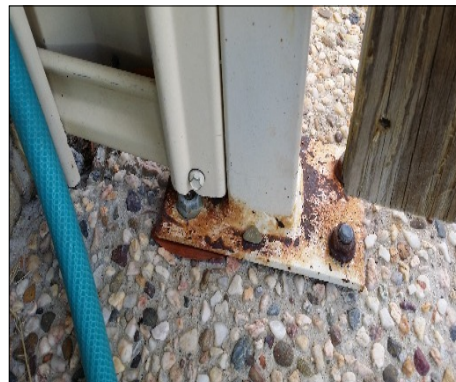
Surface corrosion to bottom of front gate posts, rust treatment and paint touchups required.

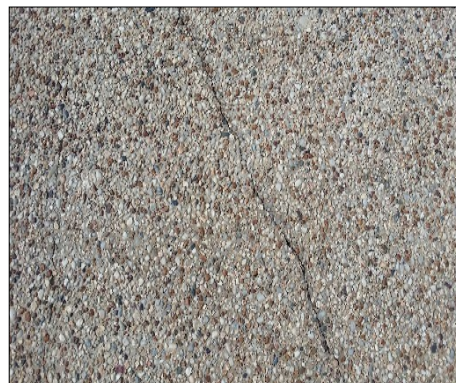
Cracking was detected to sections of concrete driveway. This is a common issue with a large percentage of homes and can be caused by many differing factors including poor ground preparation, inadequate steel reinforcing, etc. Repairs are not considered essential, monitor for further changes.

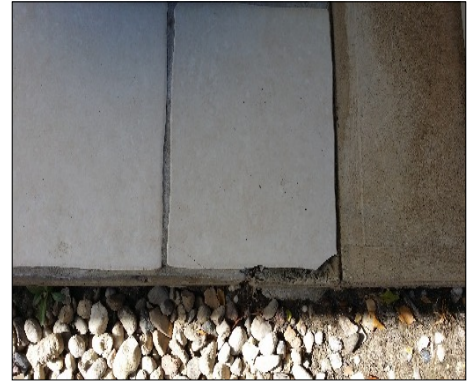
Some cracked and chipped rear patio floor tiles, replacement recommended, Recommend seeking further advice from a licensed and practicing wall and floor tiler.

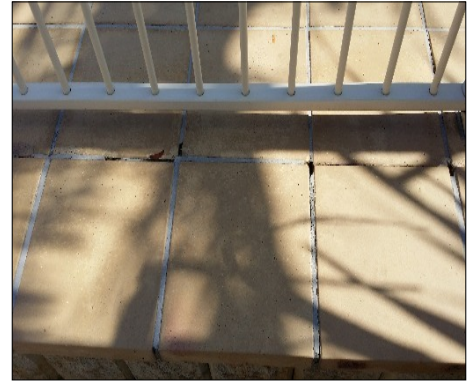
Paving mortar and expansion sealants to pool area have deteriorated, maintenance recommended, Recommend seeking further advice from a licensed and practicing paving layer for probable solution and cost.

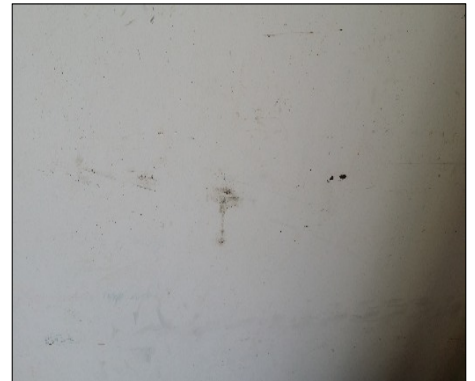
Various minor marks to plaster and paint work throughout, this is consistent with general wear and tear for a property of this age. Patching and painting will improve the overall appearance.
