TIMBER PEST INSPECTION REPORT

In accordance with AS 4349.3

45 Bellevue Drive, Little Mountain, QLD 4551
Inspection Address

5/12/2018
Date of Inspection

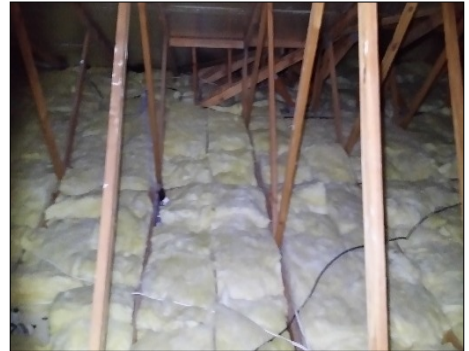
Restricted visibility to soffits/eaves.

Insulation batts obstruct visual inspection.

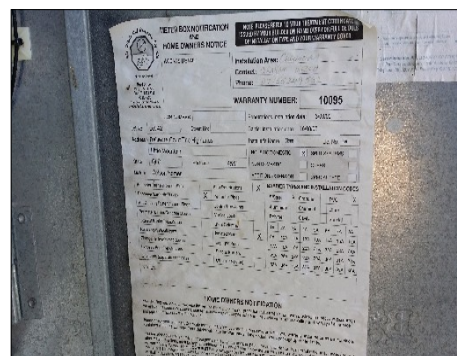
Termite treatment notice in meter box. Strongly recommend obtaining all documentation pertaining to the termite management system in place, any warranties given and if the warranties are intact and transferable prior to the contract becoming binding.
