CODE FOR DEVELOPMENT ON STEEP OR UNSTABLE LAND – GEOTECHNICAL REPORT

LOT 2 MON TERRE DRIVE, MON TERRE RIDGE ESTATE LITTLE MOUNTAIN

PROJECT DESCRIPTION: Preliminary Report

DATE: 30 January 2017

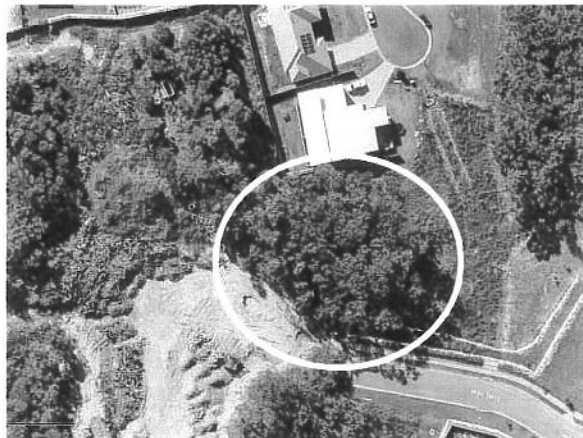
Photograph 1 – Aerial Image of the Site

The site is described as Lot 2 on Mon Terre Drive, Mon Terre Ridge Estate, Little Mountain on SP246943 and is 1250m² in area. The site is shown in the aerial photograph below (pre-development).

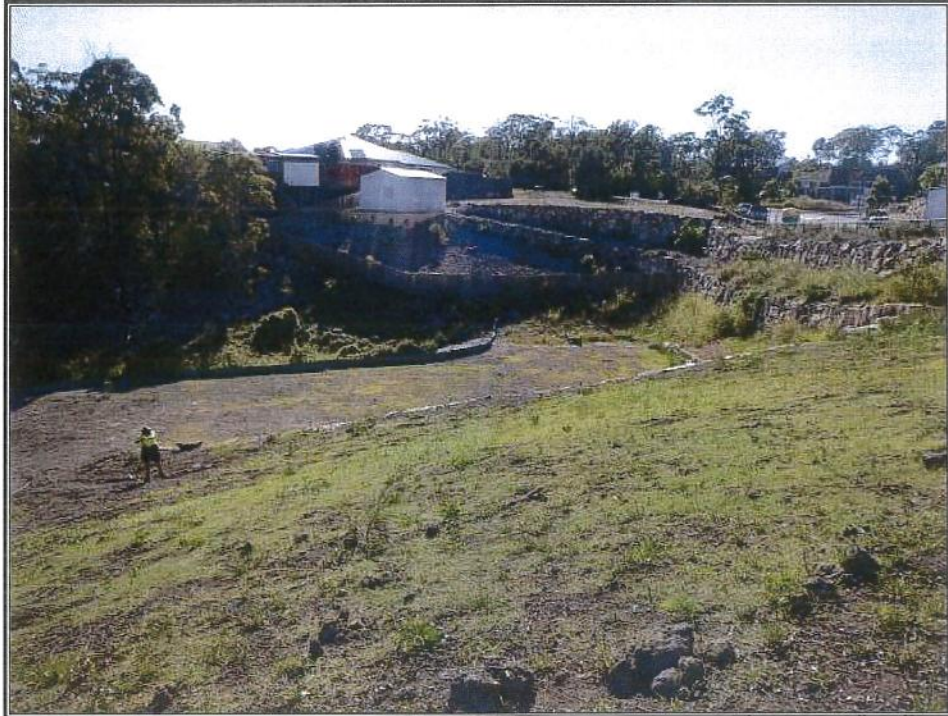
Site testing
